Manhole Inspection Summary

Manhole # S39I__038MH

Insp Date: **8/20/08 9:42 AM**

Location Address: **side 750 e pratt st**

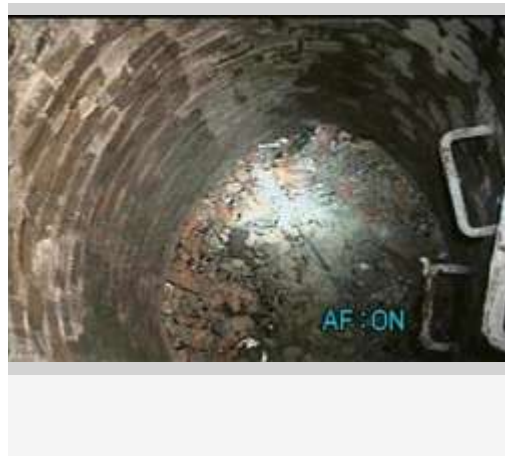
Top View

Condition: ☐ Sound ☐ Cracked ☐ Root Intrusion ☐ Deteriorated ☐ Leaks ☒ **Debris**

Steps Count: **5** Missing: **0** ☒ **Corroded**
